SUBIC BAY
FLEET MOORINGS
INSPECTION REPORT

FPO-1-82(23)

Results of the inspection indicate that eight of the 20 moorings inspected are in satisfactory condition, eight moorings do not meet design classification criteria and should be downgraded, and four moorings do not meet minimum safety requirements and should be removed from service until an overhaul is accomplished.

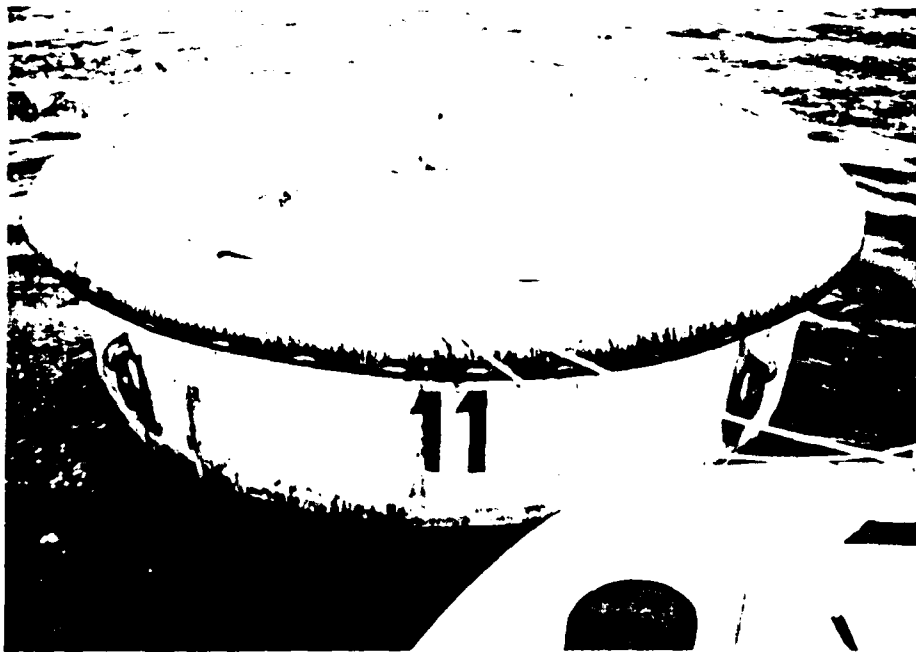
Mooring #11 — Best Topside Condition of all Subic Bay Mooring Buoys.

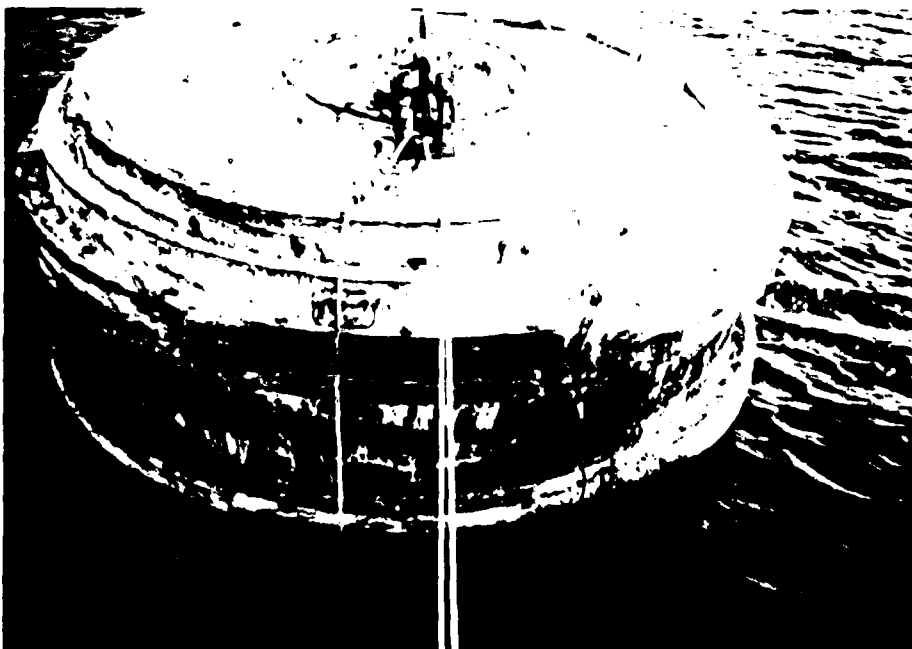
Mooring #26 — Showing Typical Side and Fender Damage.

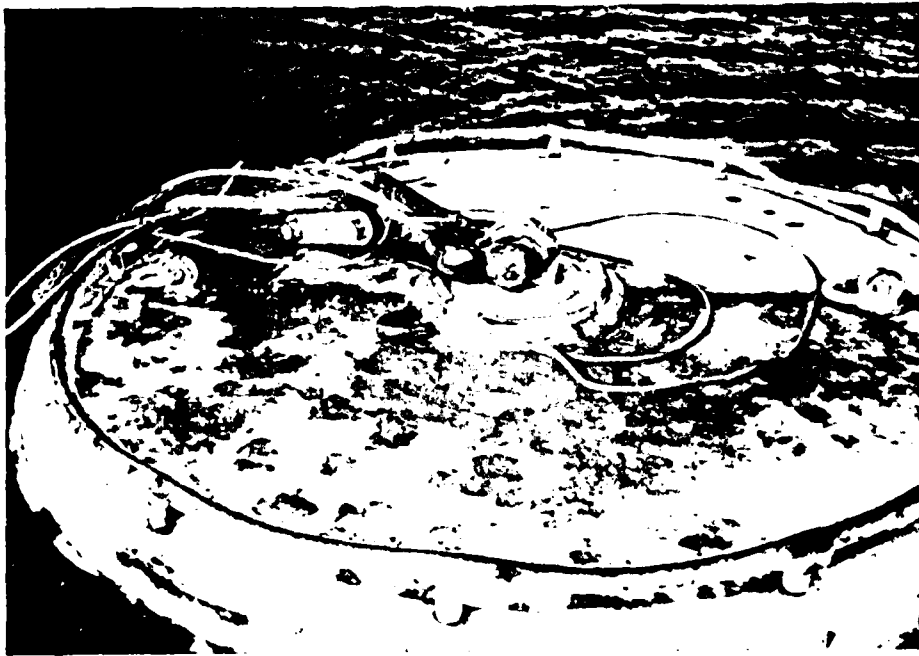
Mooring #31 — Topside Steel Decking is Loose and Rusty; Damaged Railing Also Shown.

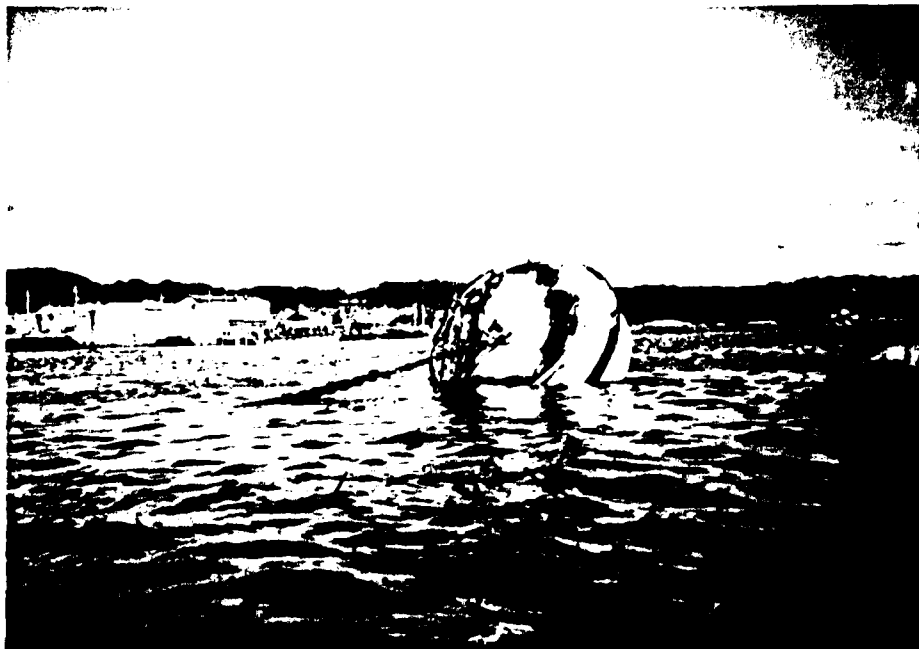
Mooring #10 — Under Load, With Topside Partially Submerged.
